THE EFFECTS OF SONIC BOOM ON STRUCTURAL BEHAVIOR

- A SUPPLEMENTARY ANALYSIS REPORT-

OCTOBER 1965

JOHN A. BLUME & ASSOCIATES RESEARCH DIVISION

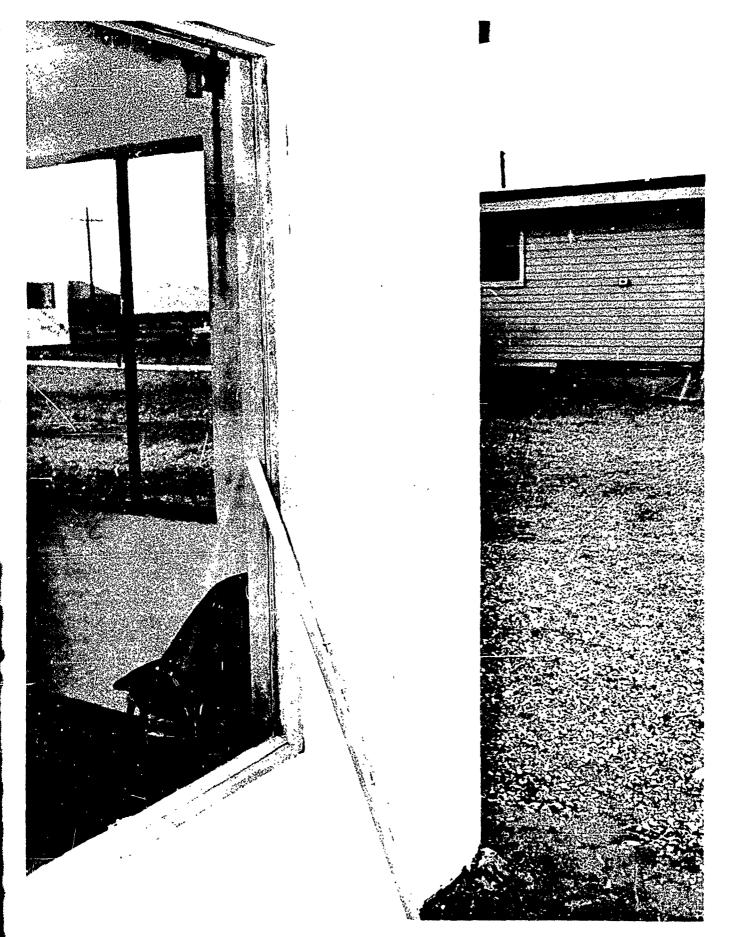
Fig. IX-6 Molding on $5' \times 10' \times 1/4"$ Window Popped off During a 38 psf Boom. Note that Only One Nail Held the Molding and that the Window Did Not Break. None of 12 Windows of this Size Broke on this Critical Vector Boom. 166
